Subject: September 2018 Clean Water Act Compliance Inspection

CWA COMPLIANCE EVALUATION INSPECTION REPORT
U.S. ENVIRONMENTAL PROTECTION AGENCY, REGION 5

Purpose: Compliance Evaluation Inspection

Date of Inspection: September 6, 2018

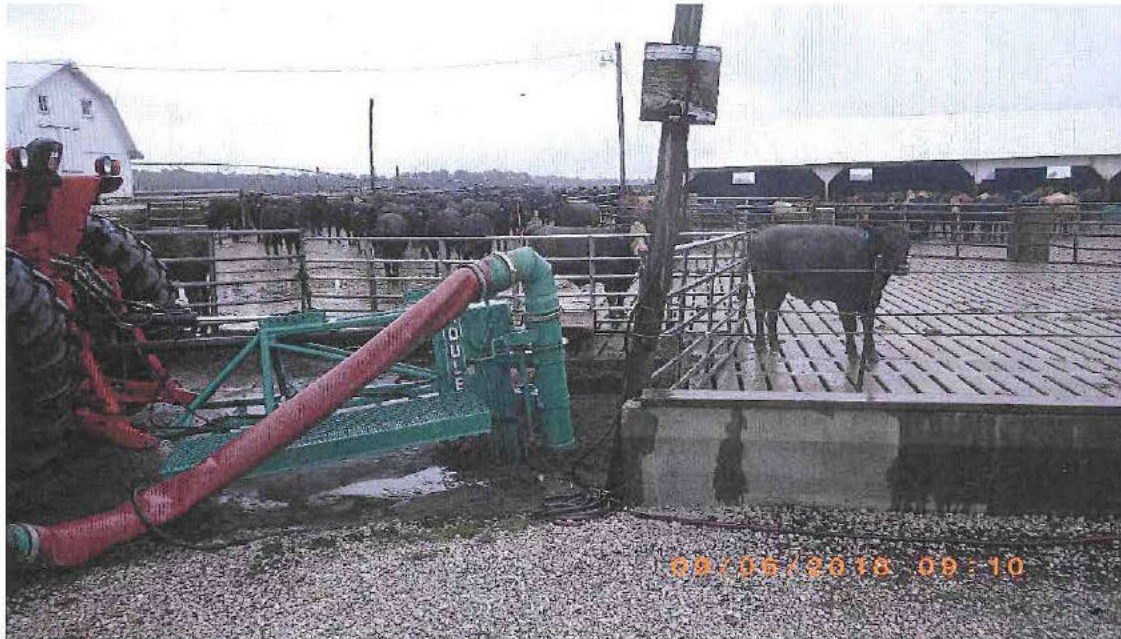
2: RIMG0371

Description: The feedlot at the satellite site contained a concrete slatted floor. The manure pump out location was located along the southern end of the feedlot.

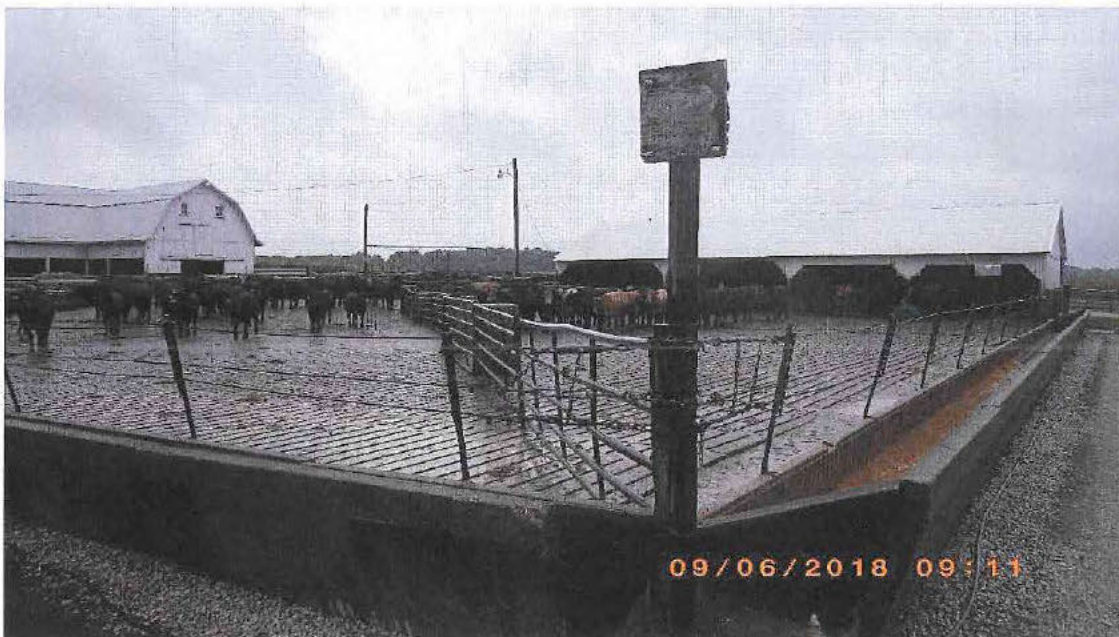
3: RIMG0372

Description: The feedlot at the satellite site contained a concrete slatted floor. Concrete feed troughs were located along the perimeter of the feedlot.

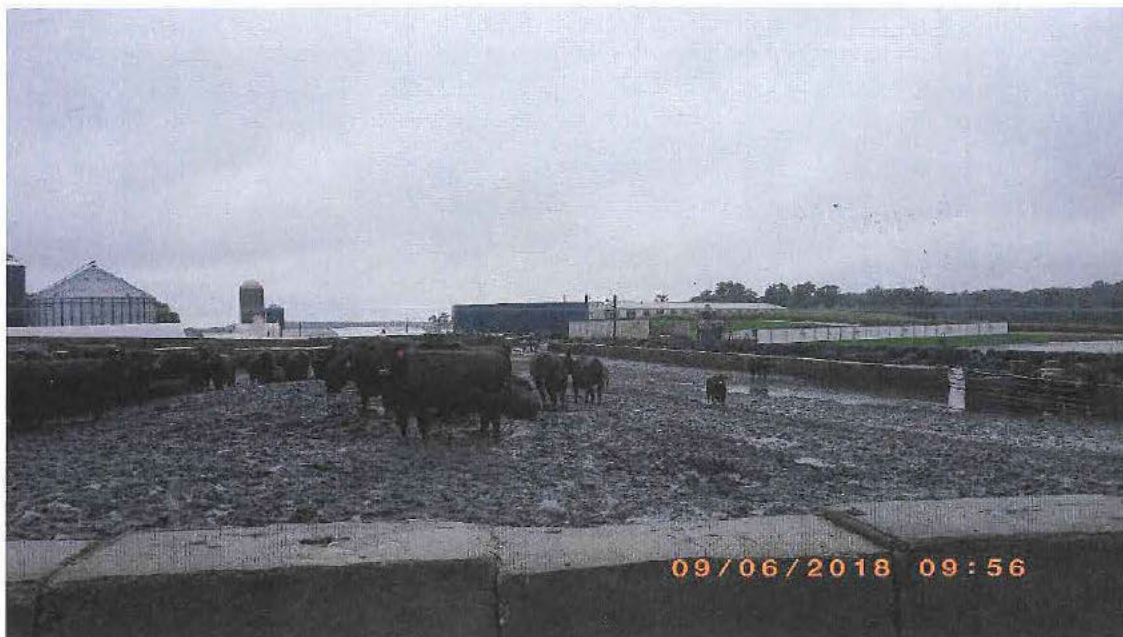
7: RIMG0376

Description: Cattle feedlot on the north end of the [REDACTED] Beef site. Runoff from the feedlot is collected in the waste storage facility.

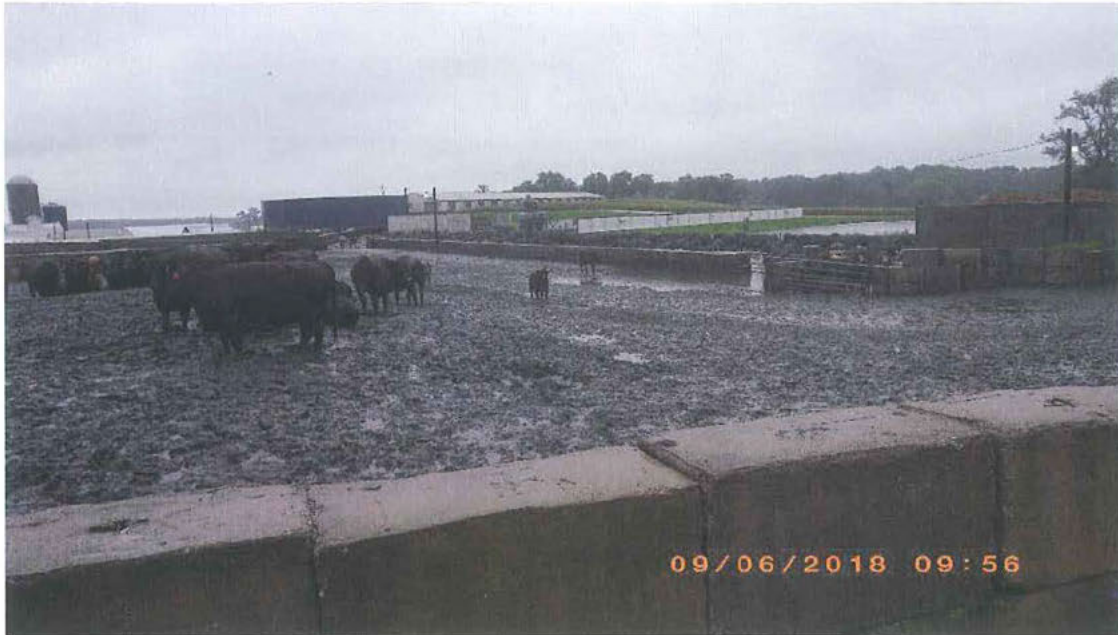
8: RIMG0377

Description: Cattle feedlot on the north end of the [REDACTED] Beef site. Runoff from the feedlot is collected in the waste storage facility.

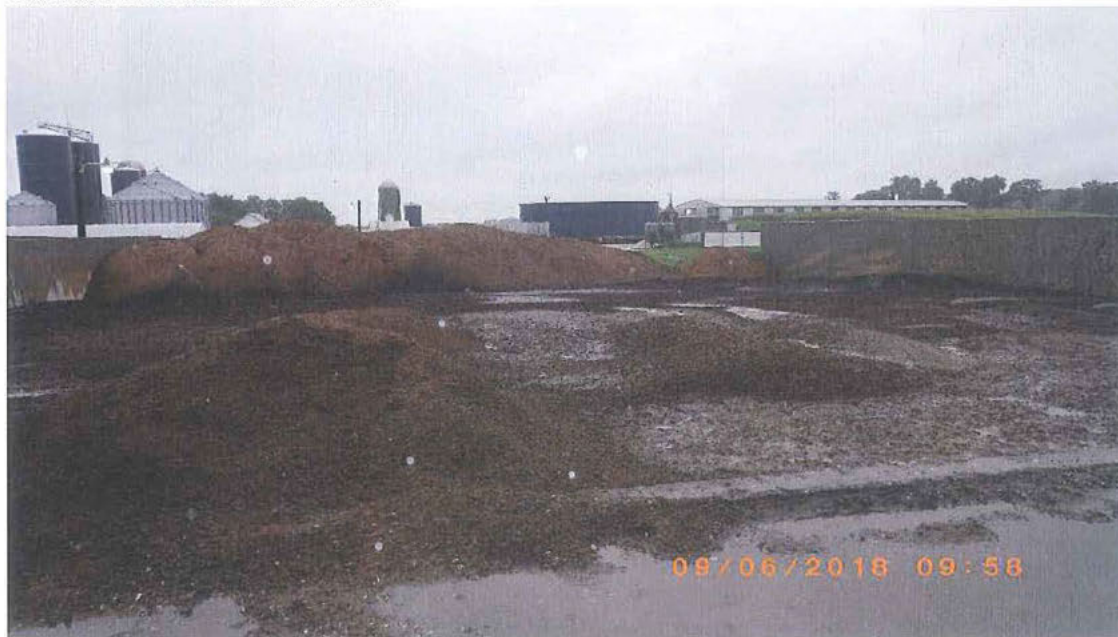
9: RIMG0378

Description: A solid manure stacking area was located at the north end of the [REDACTED] Beef site. Runoff from the manure stacking area is collect in the waste storage facility.

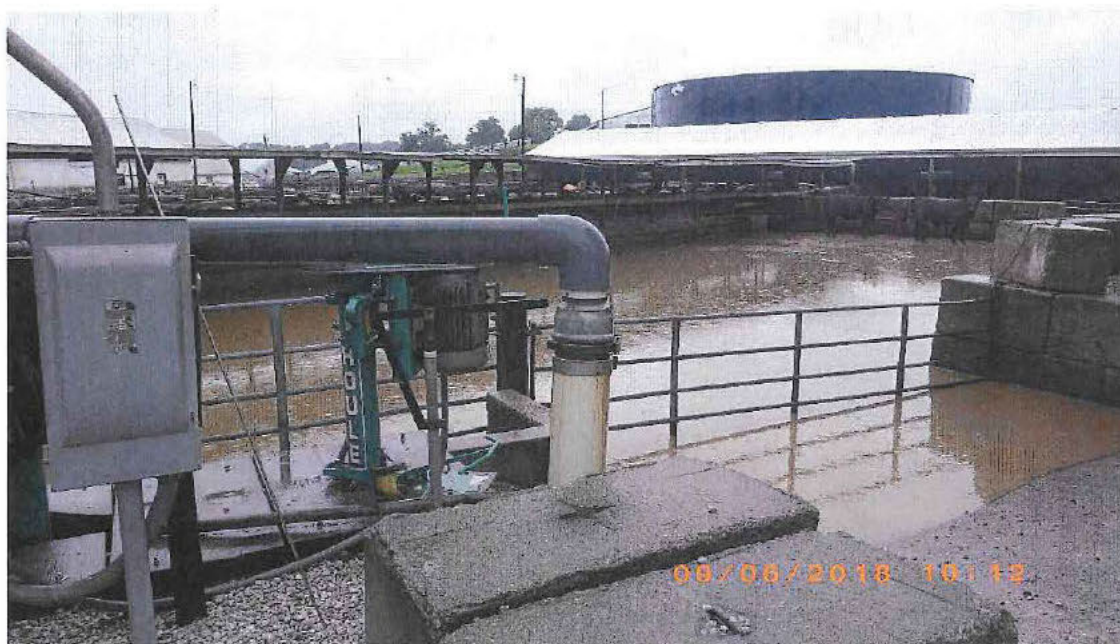
10: RIMG0379

Description: A pump station "gate" was located at the east end of the central feedlots.

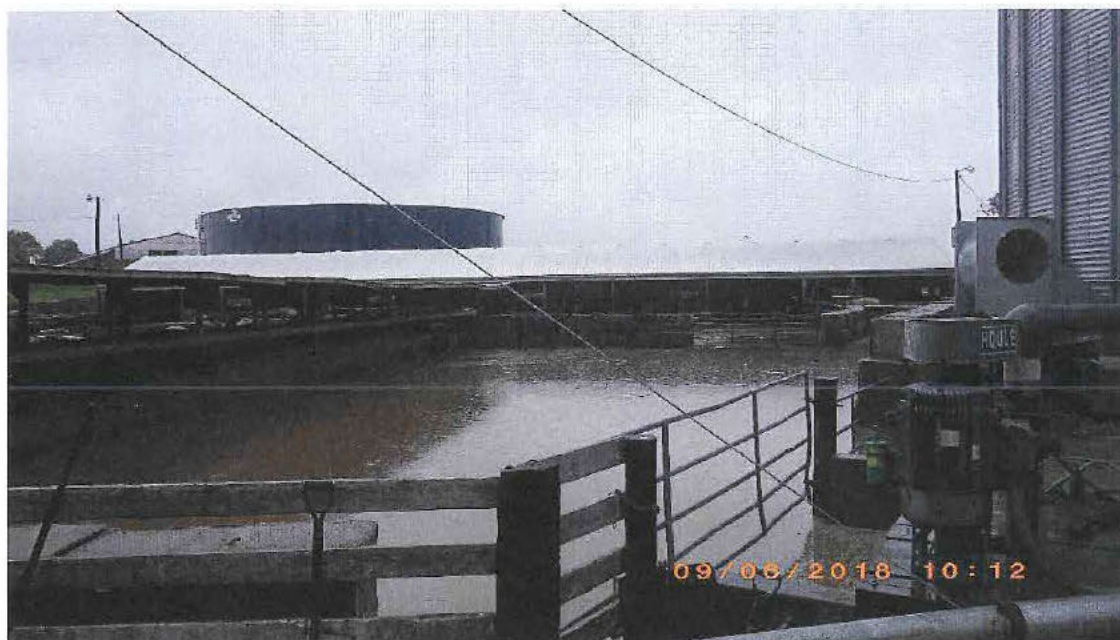
11: RIMG0380

Description: A pump station "gate" was located at the east end of the central feedlots.

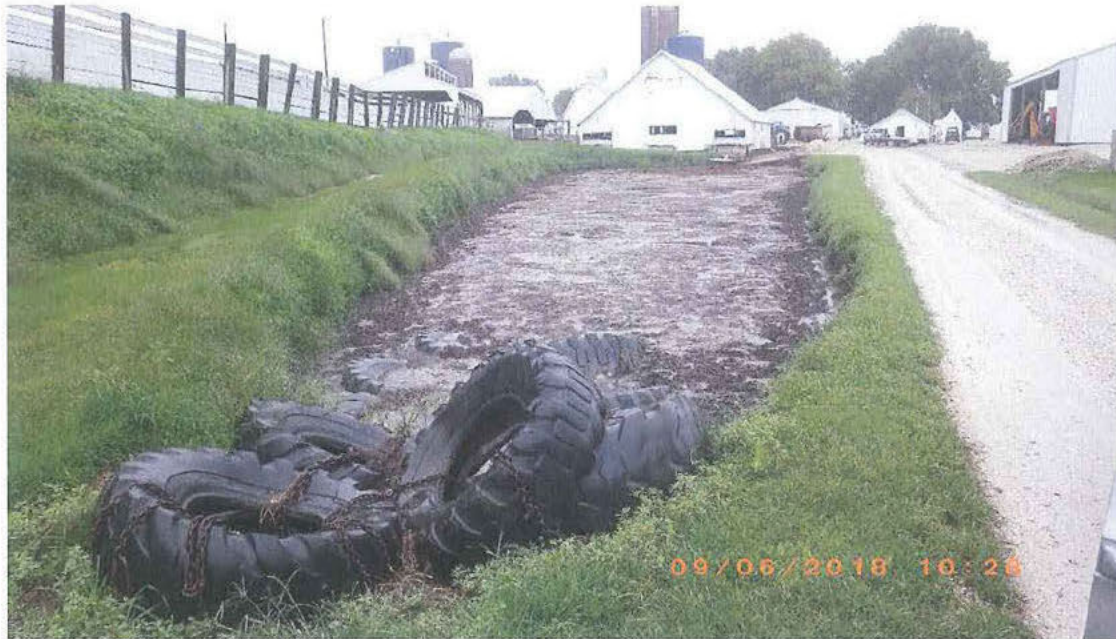
12: RIMG0381

Description: A solids settling pond was located along a farm drive at the southern end of the Beef site. The solids settling pond is piped to the south under the farm drive and flows into a small ditch that is sloped to the west. The ditch flows to the large waste storage facility.

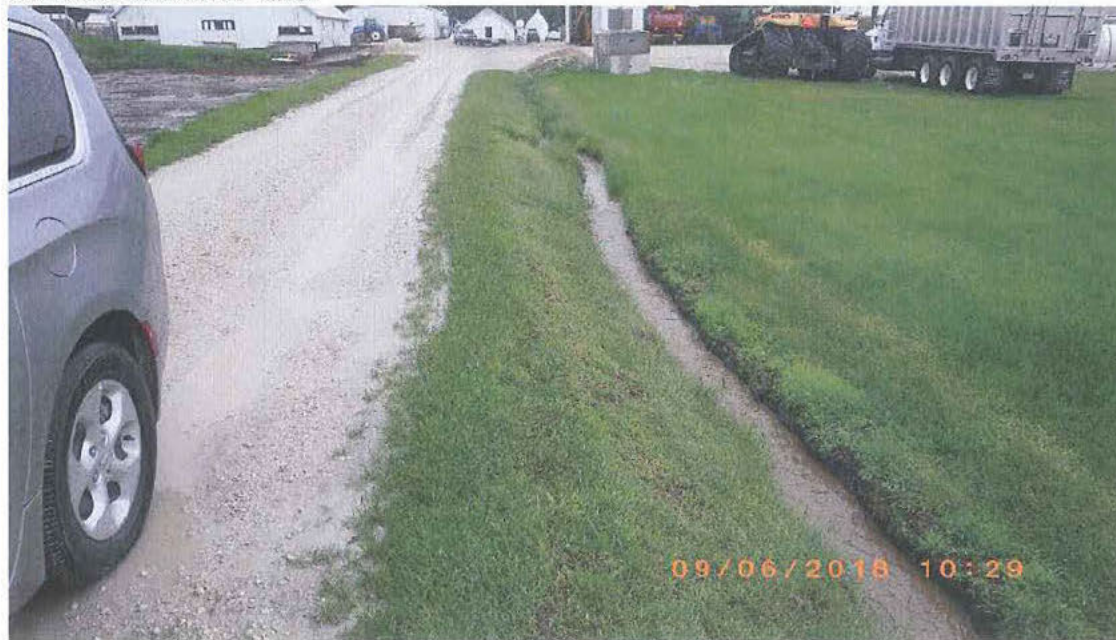
13: RIMG0382

Description: The solids settling pond is piped to the south under the farm drive and flows into a small ditch that is sloped to the west. The ditch flows to the large waste storage facility.

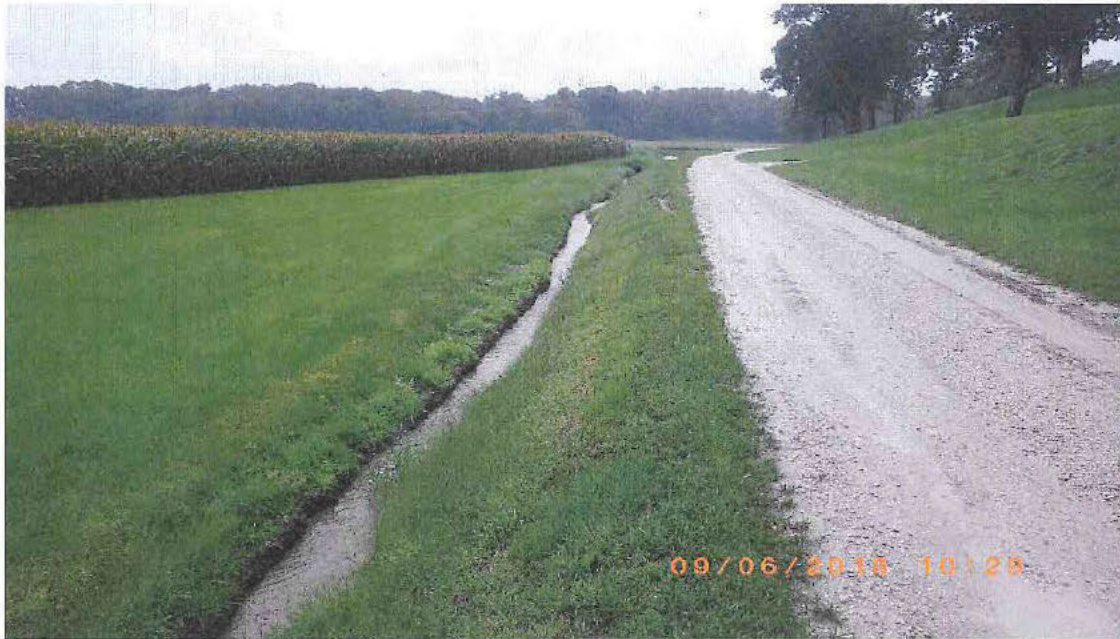
14: RIMG0383

Description: The solids settling pond is piped to the south under the farm drive and flows into a small ditch that is sloped to the west. The ditch flows to the large waste storage facility.

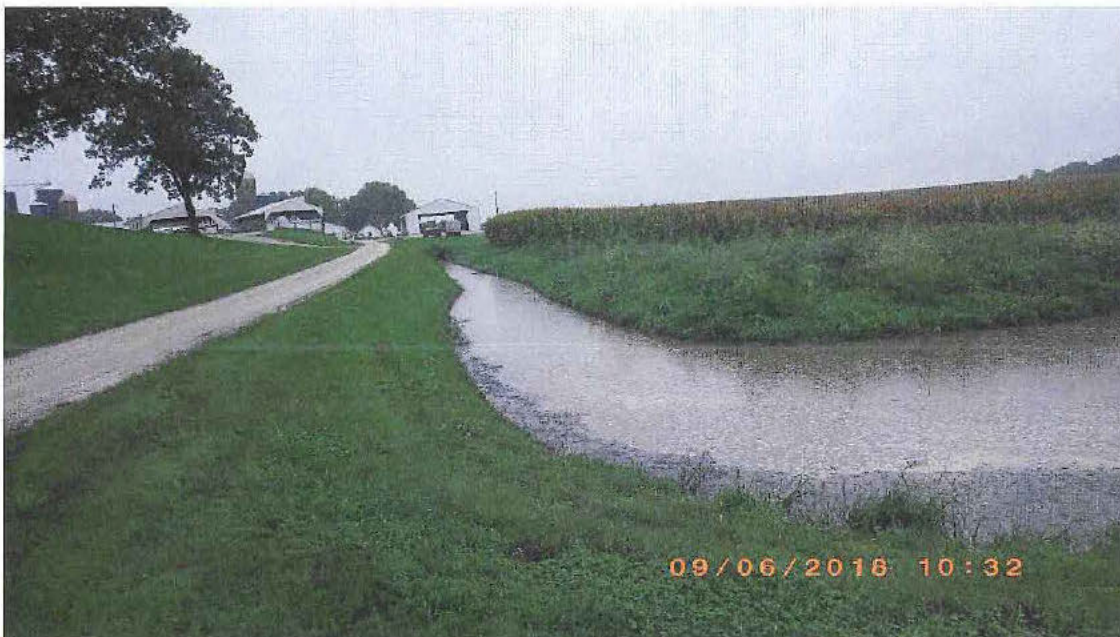
15: RIMG0384

Description: A large ditch forms and the flow continues west until it bends and continues south to the large waste storage facility.

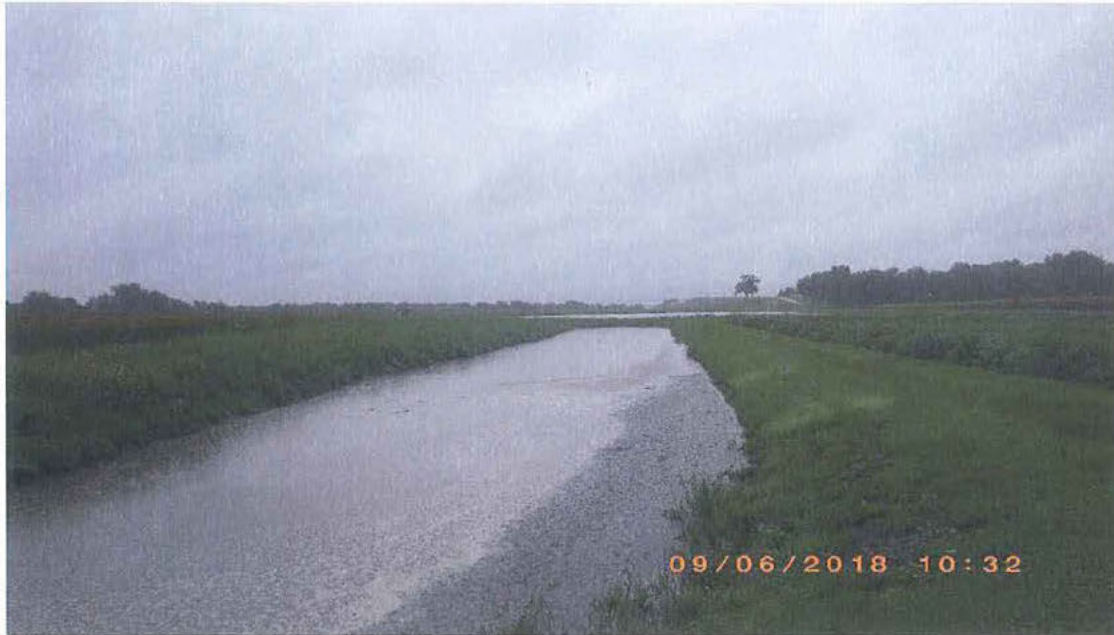
16: RIMG0385

Description: The flow continues into a large ponded area and continues south to the large waste storage facility.

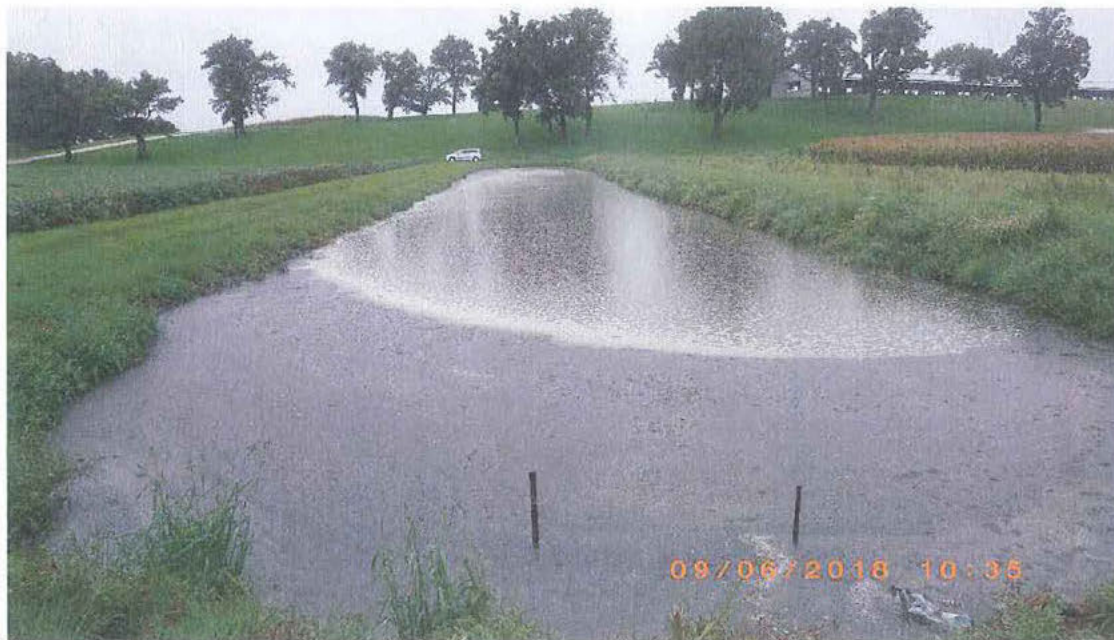
17: RIMG0386

Description: The flow continues into a large ponded area and continues south to the large waste storage facility.

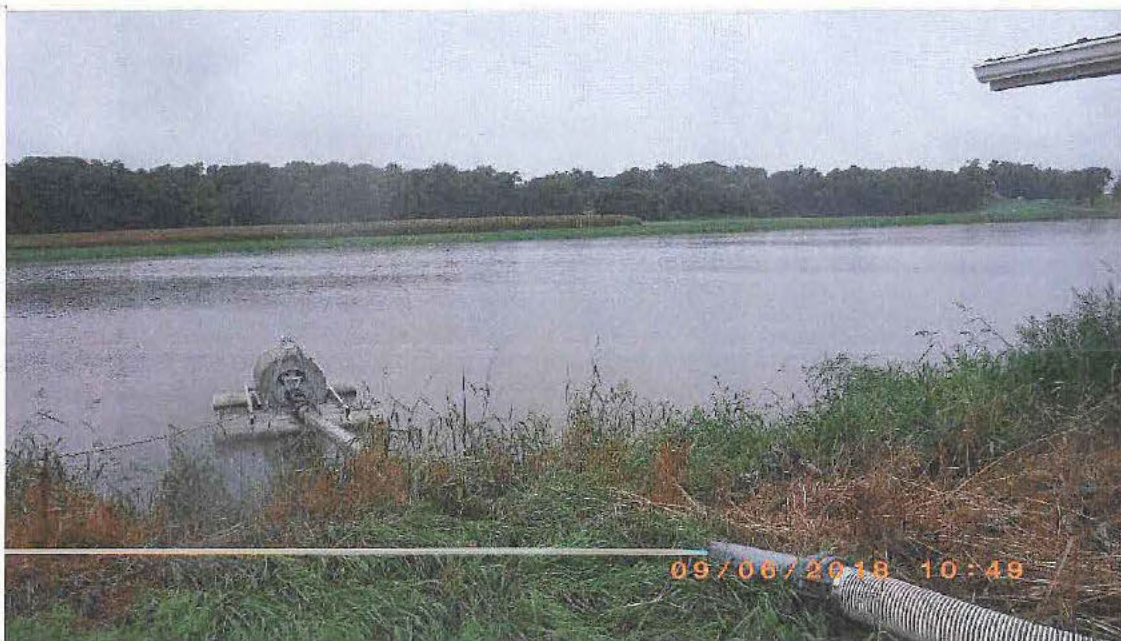
19: RIMG0388

Description: A tractor driven manure pump was located at the east end of the large waste storage facility.

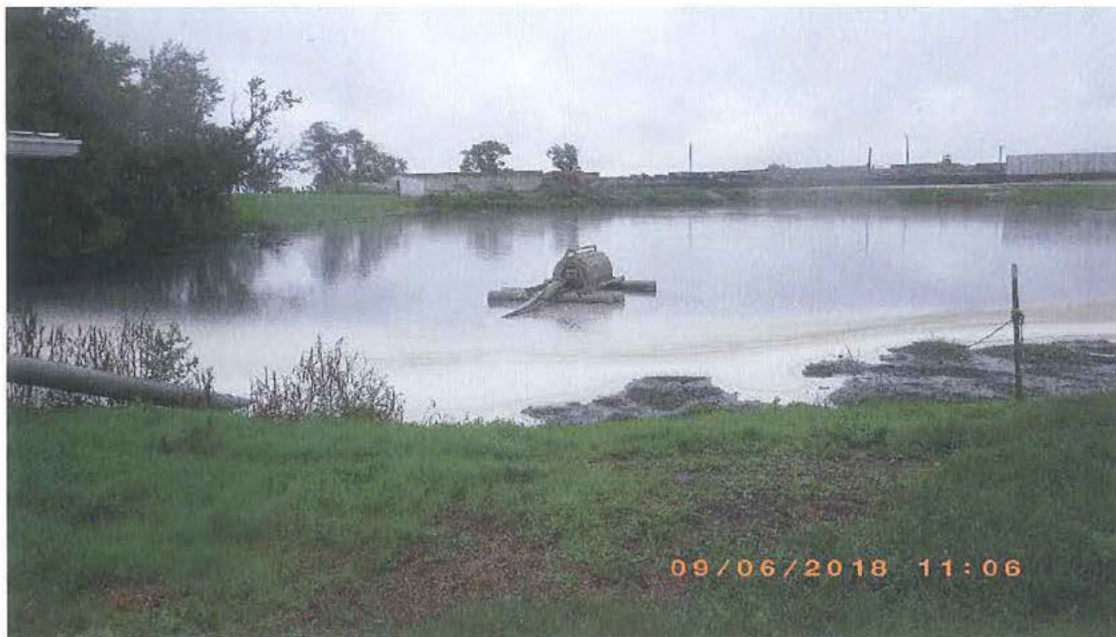
20: RIMG0389

Description: A pump was located on the west end of the northwest waste storage facility.

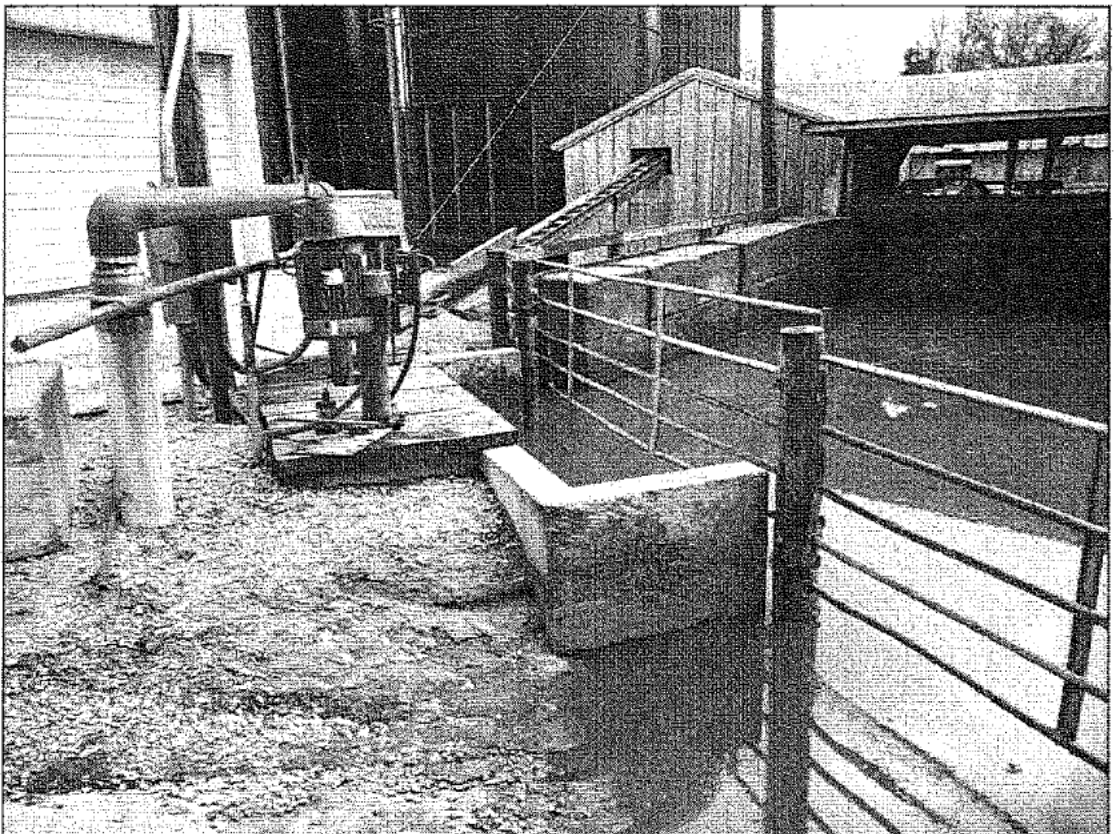
Photograph #10

View toward the
south of a runoff
collection sump
and lift station

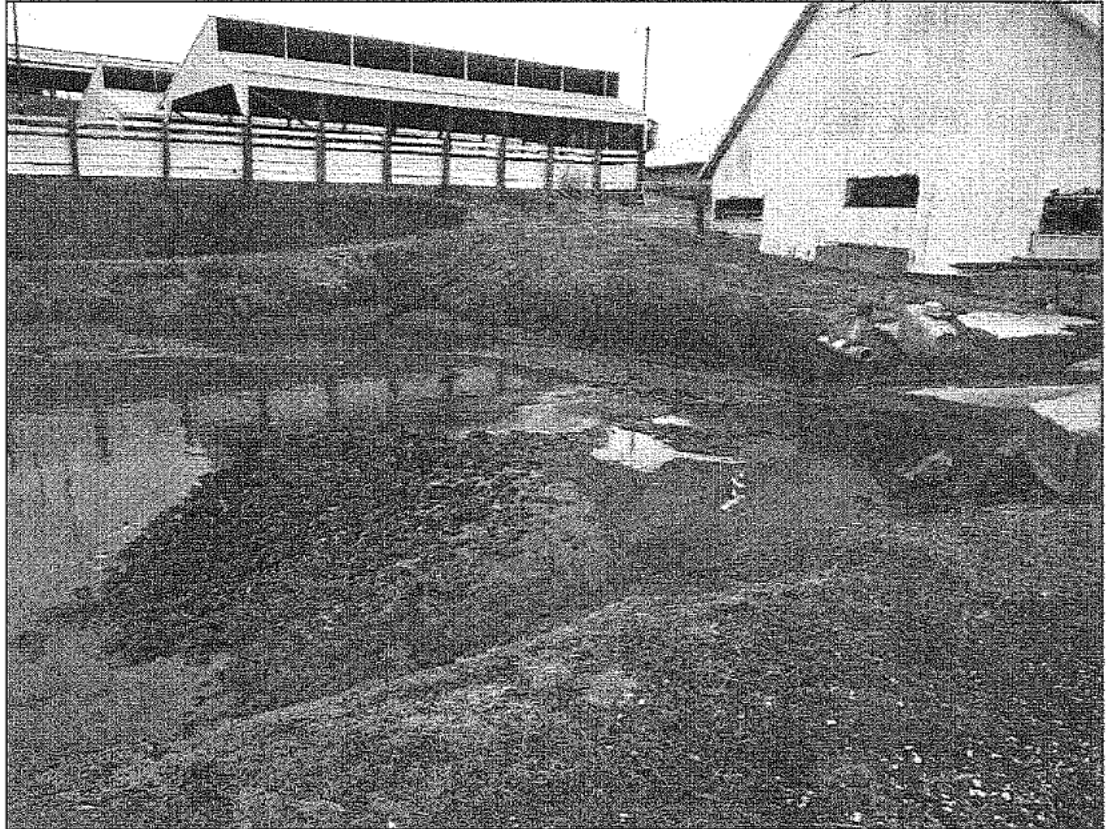
Photograph #11

View toward the
northeast of the
drain line outfalls
to Settling Pond 1

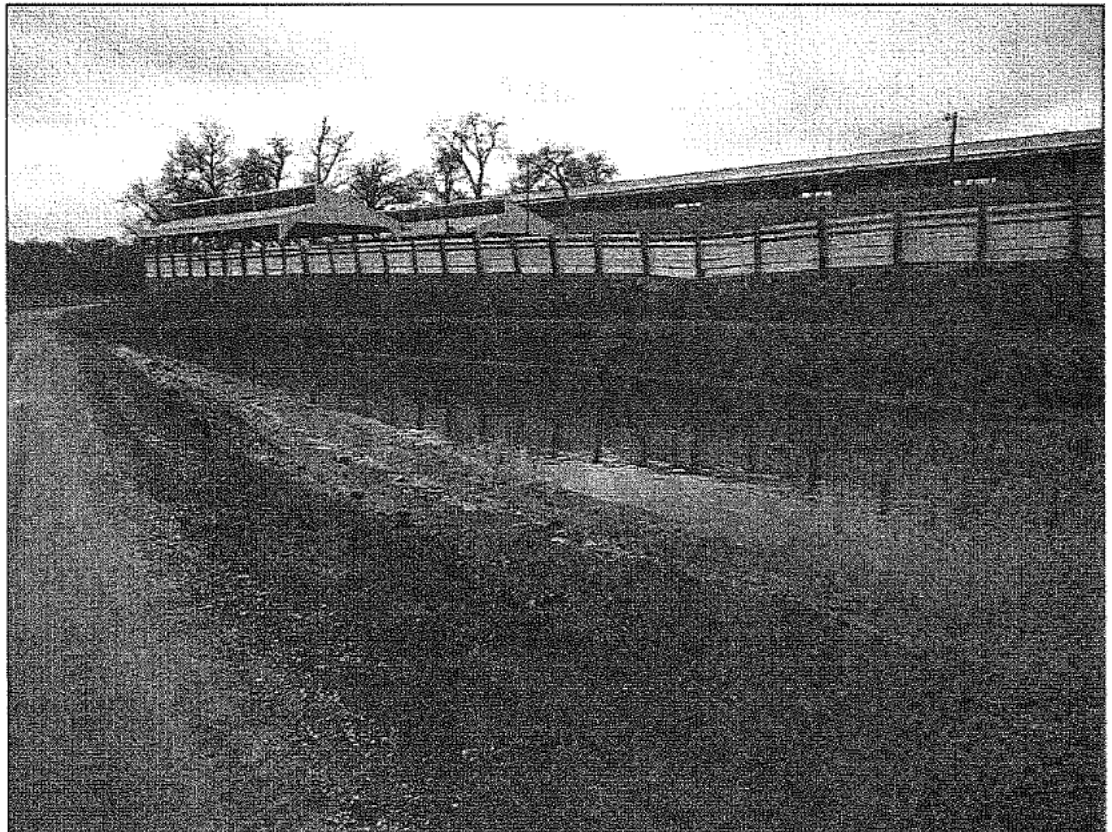
Photograph #12

View toward the
northwest of the
drainage path from
Settling Pond 1 to
Storage Pond 1

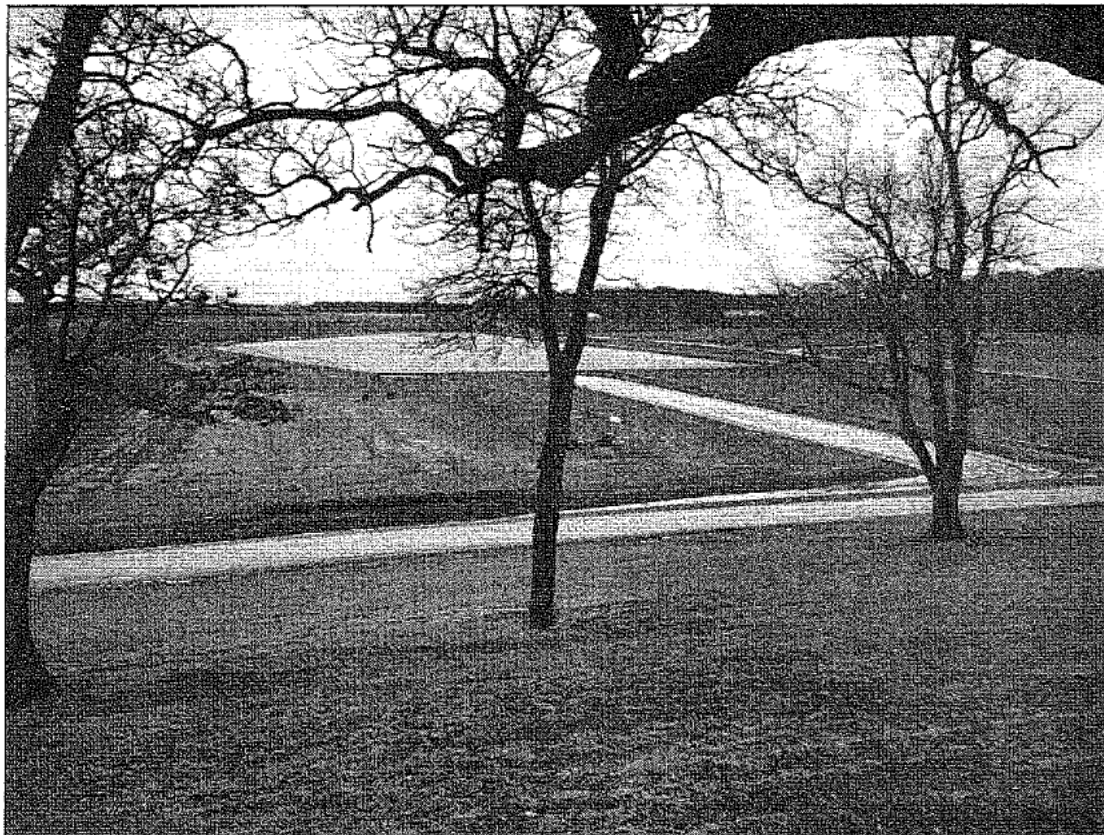
Photograph #13

View toward the south of the drainage canal between Settling Pond 1 and Storage Pond 1

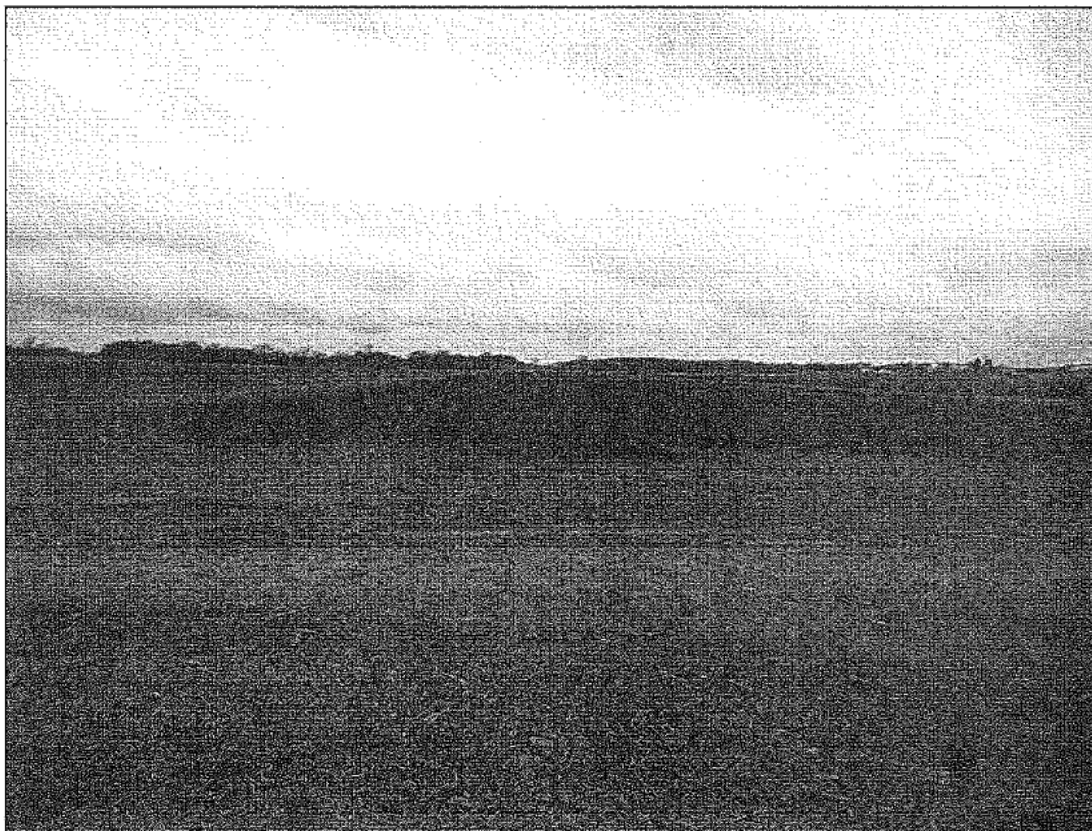
Photograph #15

View toward the west of the land application field that received a surface application of manure solids that day

While I was making the stream observations, at approximately 11:35 AM, I observed land application activity in the field directly east of the facility's production area. A worker was applying solid livestock waste to the field surface via a manure spreader. The field surface was not frozen, ice-covered, or snow-covered. The soil in this part of Henry County has a high sand content and, therefore, a high permeability. The entire field is in a depression and does not require ditch drainage. There appeared to be no risk to area surface waters from this application of livestock waste.
